**NASA
Technical
Paper
2950**

**The Interlaminar Fracture
Toughness of Woven
Graphite/Epoxy Composites**

Joan G. Funk
and Jerry W. Deaton
*Langley Research Center
Hampton, Virginia*

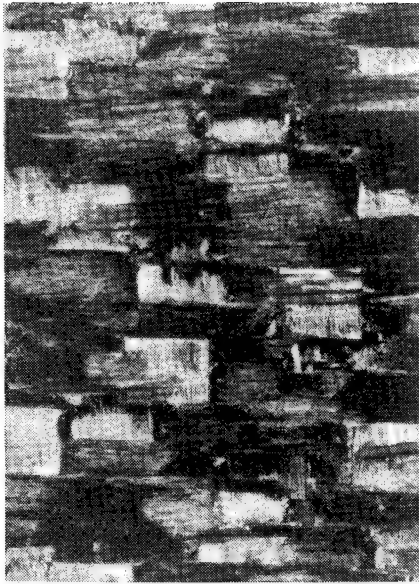
Figure 16. Failure surfaces of 5-harness satin weave specimens in the folded configuration.

5-harness satin weave. As shown in figure 1, the pattern of the satin weaves is not the same on the top and bottom surfaces and should result in a failure surface appearance and G_{Ic} dependent on whether two similar or two dissimilar surfaces are located at the crack plane. In figure 16 the failure surfaces of the 5-harness satin weave composite in the folded configuration are shown. Both sides of the failure surfaces are similar. In the warp direction the largest percentage of the visible fibers (warp yarn floats) run parallel to the direction of crack growth, whereas in the fill direction they run perpendicular to the direction of crack growth. The G_{Ic} value was substantially higher for the material tested in the fill direction.

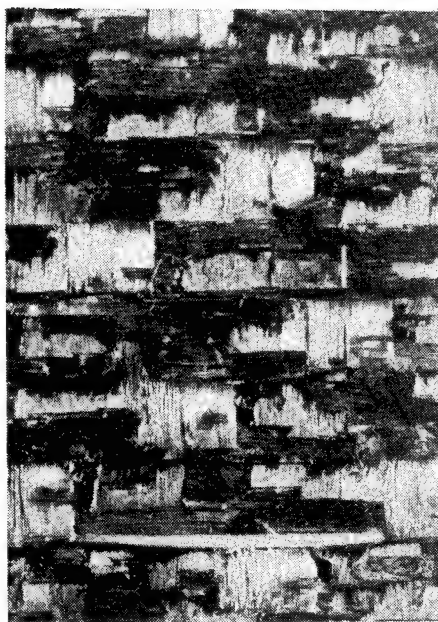
L-89-114

Figure 17. Failure surfaces of 5-harness satin weave specimens in the stacked configuration.

Figure 17 shows the failure surfaces of the stacked configuration of the 5-harness satin weave material. Both sides of the failure surface of the material tested in the warp and fill directions are similar in appearance. The failure surfaces of the stacked configuration generally resemble each other regardless of the test direction, and G_{Ic} is essentially the same for both test directions.

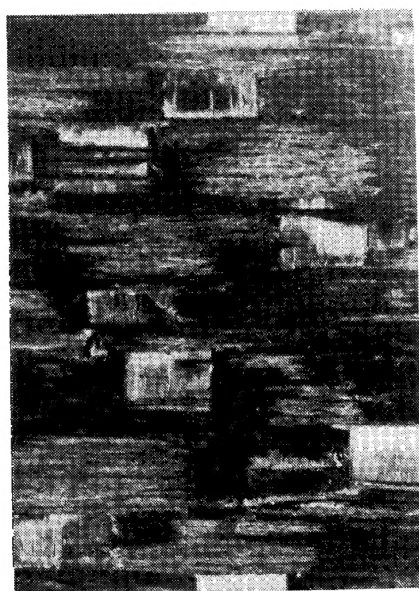
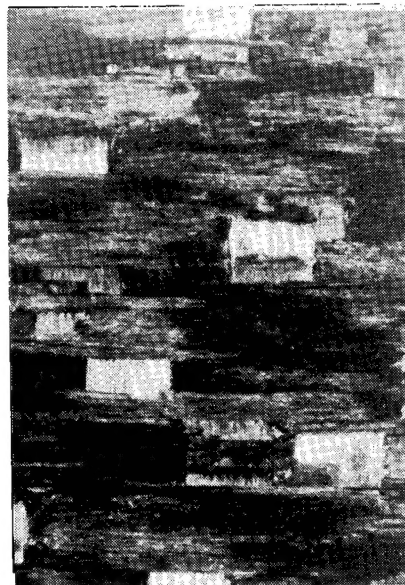
Warp Direction of crack growth Fill L-89-115

Figure 18. Failure surfaces of 8-harness satin weave specimens in the folded configuration.

8-harness satin weave. In the folded configuration of the 8-harness satin weave shown in figure 18, both sides of the failure surface for either the warp or the fill test directions are similar in appearance. In the warp direction the largest percentage of visible fibers (warp yarn floats) run parallel to the direction of crack growth, whereas in the fill direction they run perpendicular to the direction of crack growth. In the 5-harness satin weave material in the folded configuration, the specimens with the largest percentage of visible fibers perpendicular to the direction of crack growth had a higher G_{Ic} than those with the largest percentage of fibers parallel to the direction of crack growth.

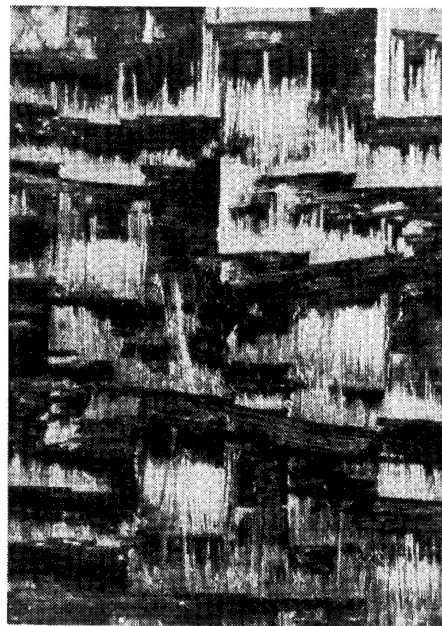
L-89-116

Figure 19. Failure surfaces of 8-harness satin weave specimens in the stacked configuration.

When the 8-harness satin weave specimens in the stacked configuration are tested in the warp direction (see fig. 19), the floats in the fill direction and the crimped warp yarns are clearly visible in both failure surfaces. Both sides of the failure surface are similar in appearance. The failure surfaces of the stacked 8-harness satin specimens were similar regardless of the test direction, as was the G_{Ic} value for this material in this configuration.

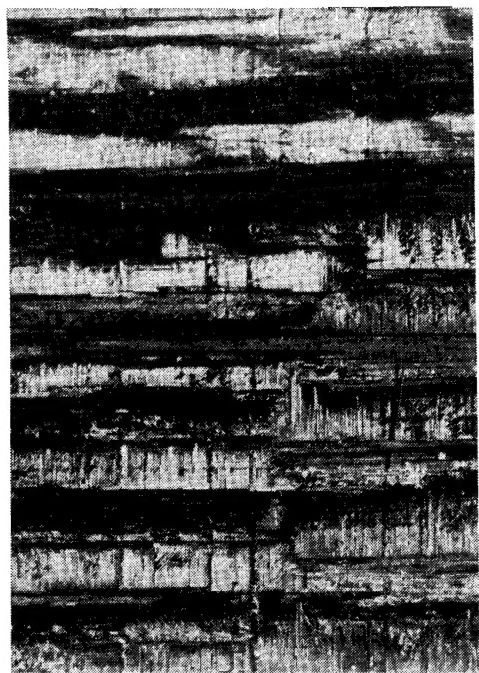
L-89-117

Figure 21. Failure surfaces of [0₁₅, 90]_s specimen.

Since data from unidirectional tape laminates tested in the 90° direction were not available for comparison, a $[0_{15}, 90]_s$ laminate was fabricated and specimens were machined, as previously described, to evaluate the interlaminar fracture toughness in the 90° direction. Data from these specimens and data from the 0° unidirectional specimens (ref. 12) are shown in figure 20. The G_{Ic} value of the 90° specimens was six times greater than that of the 0° specimens. Figure 21 shows photographs of the failure surface of a $[0_{15}, 90]_s$ specimen. Both sides of the failure surface are similar in appearance. The failure surface shows the 90° plies perpendicular to the direction of crack growth and a portion of the underlying layer of 0° fibers. The crack grew through the 90° plies as well as alternating between the 0° and 90° ply interfaces. The tape data confirm the trend observed for the satin weave and oxford weave data; that is, when the fibers are predominantly perpendicular to the direction of crack growth, the material exhibits a higher interlaminar fracture toughness than when the fibers are predominantly parallel to the direction of crack growth.
